MOHAWK RIVER BASIN
TOWN OF GERMAN FLATTS
HERKIMER COUNTY, NEW YORK

**ILION RESERVOIR
NO. 2 DAM
NY 00185**

PHASE I INSPECTION REPORT
NATIONAL DAM INSPECTION PROGRAM

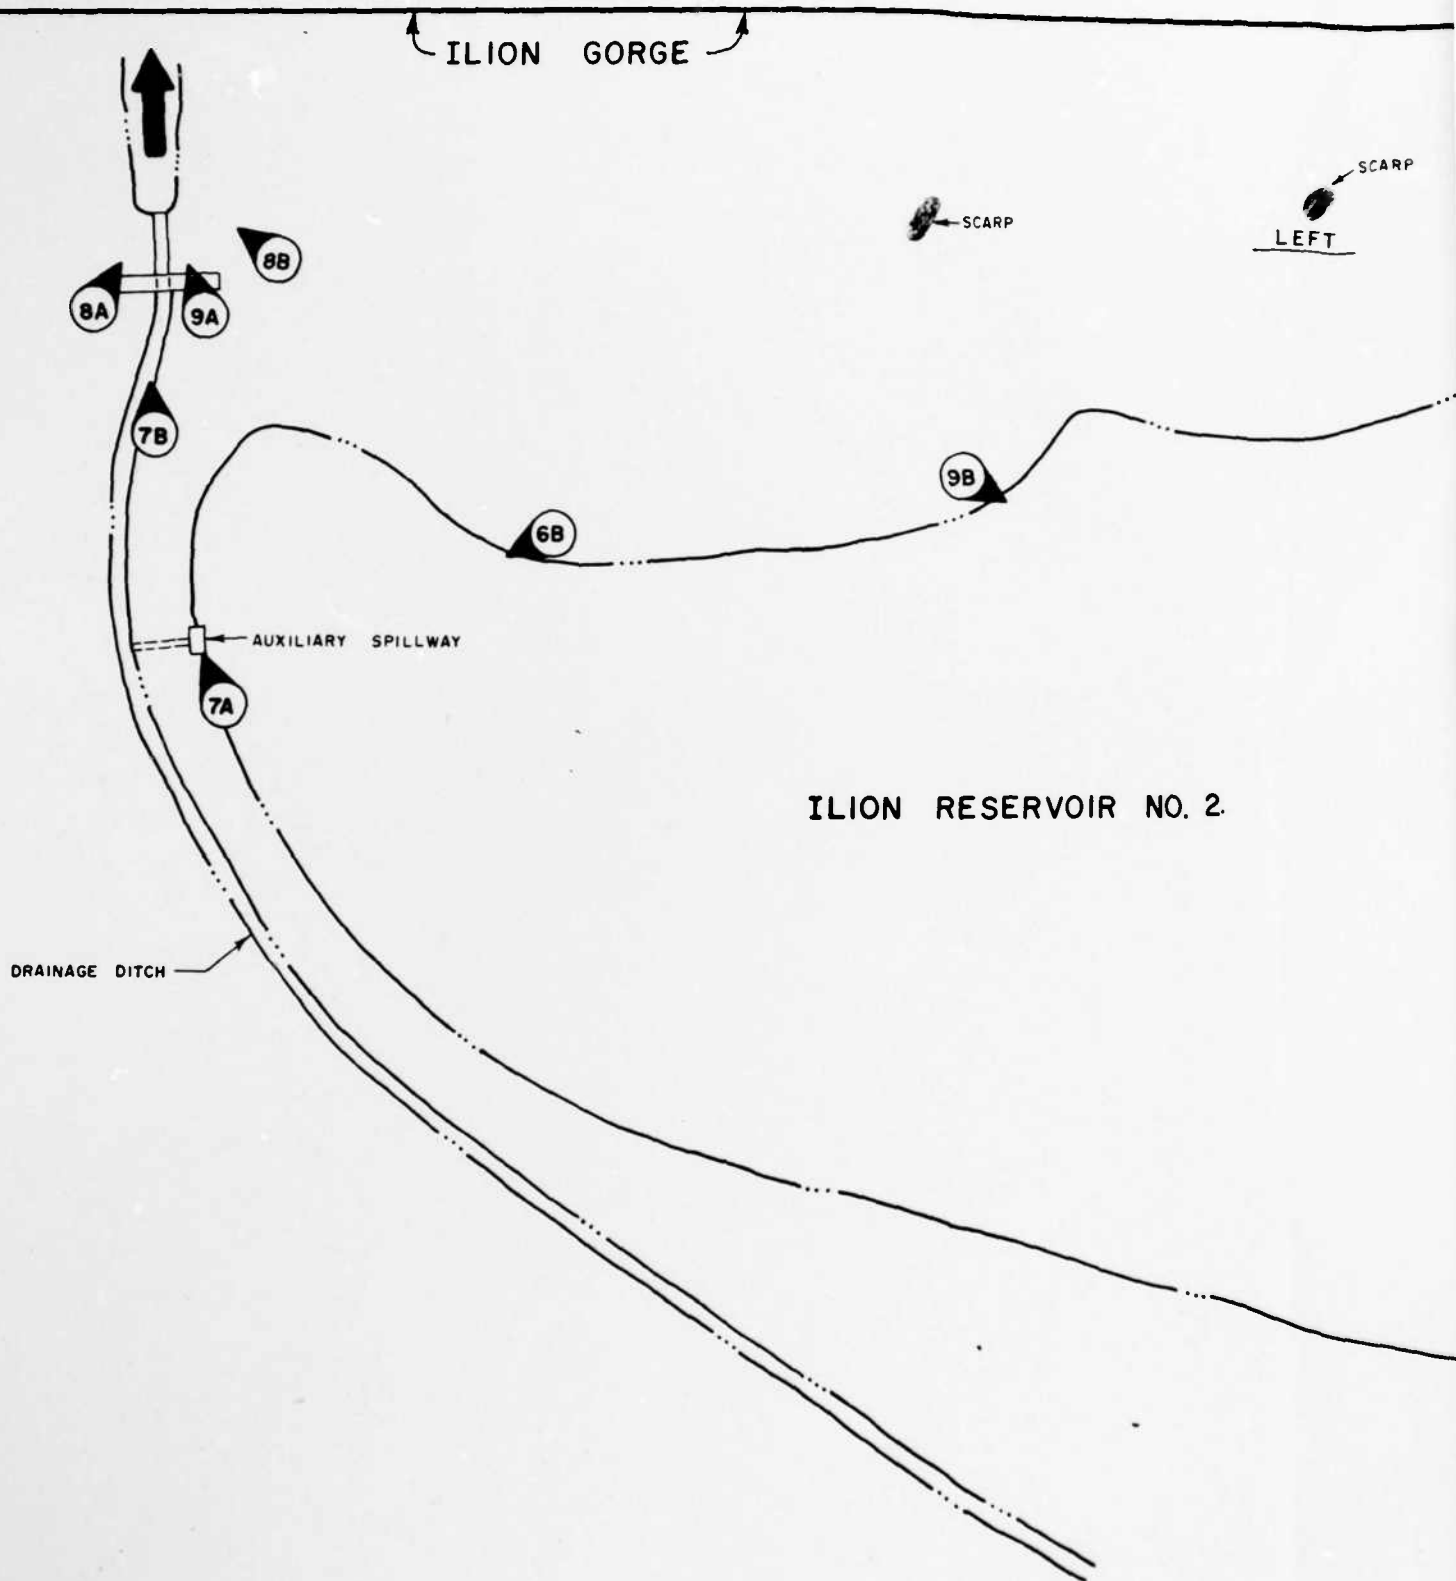
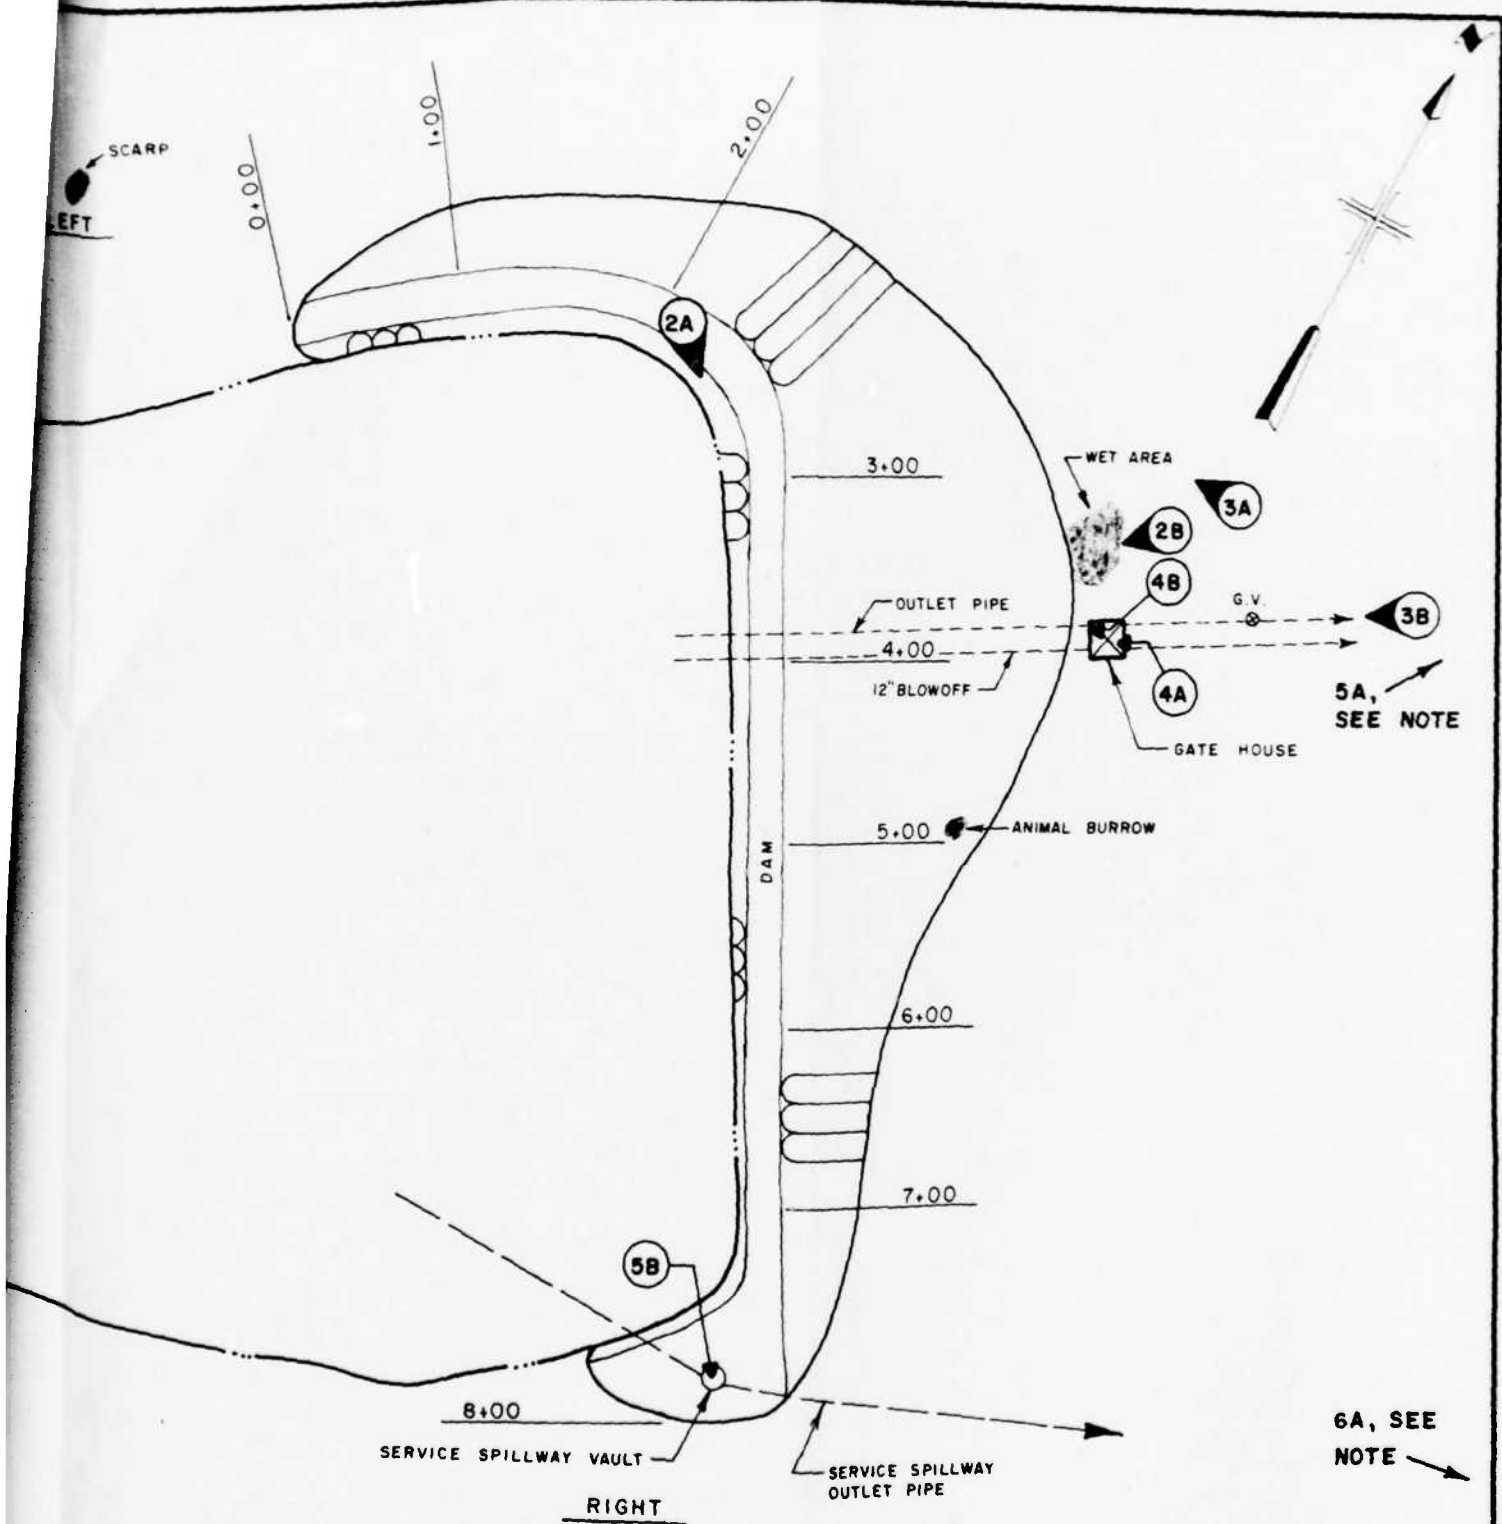
ILION RESERVOIR NO. 2 DAM	
PHOTO INDEX MAP	
TOWN OF GERMAN FLATTS	HERKIMER CO., N.Y.
SCALE: NONE	DATE JULY 1981
  C. T. MALE ASSOCIATES, P. C. 1000 TROY ROAD, SCHENECTADY, N. Y. 12309 <small>PROFESSIONAL ENGINEERS LAND SURVEYORS LAND PLANNING CONSULTANTS</small>

PHOTOS NOT LOCATED

PHOTO 5A IS AT D/S END OF BLOWOFF

PHOTO 6A IS AT D/S END OF SERVICE SPILLWAY OUTLET PIPE
